RE: Site Inspection, Sinbad Mining Company, Sinbad Mine, M/015/030, Emery County, Utah

Date of Inspection: August 20, 1998  
Time of Inspection: 1650 - 1735  
Conditions: Partly cloudy, hot  
Participants: Tony Gallegos, DOGM

Purpose of Inspection: To examine the reclaimed mine site while in the area in consideration of release of the site.

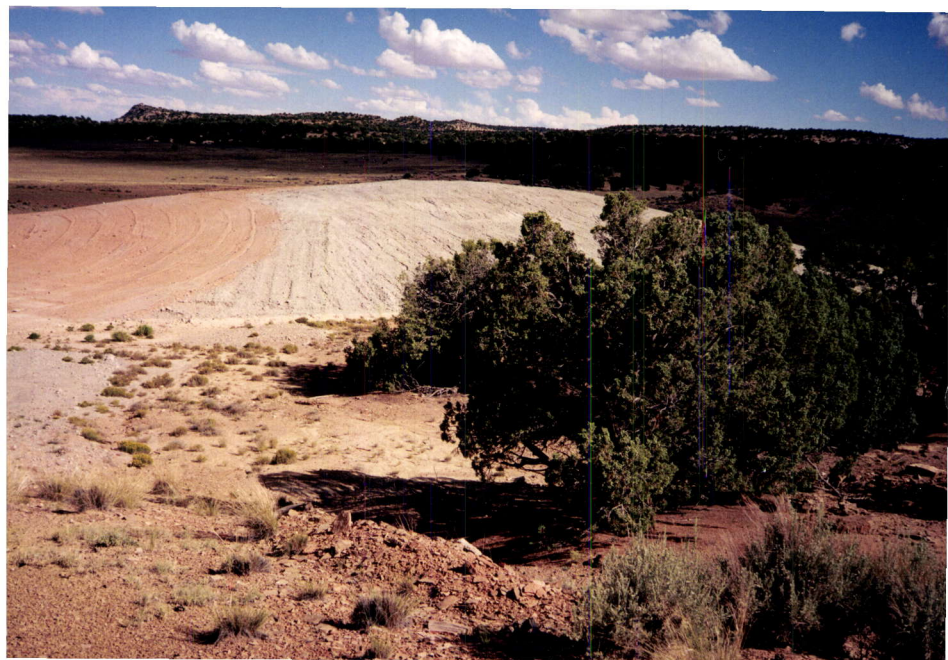
SUSPECTED  
SHAFT SITE

From the mine portal site I walked along the ridge running to the west of the site looking for the shaft site. Along this route there are several locations with drill cuttings and one drill pad that had been graded, but not reclaimed. I believe these features were not associated with this mine operation. Photographs were taken at what was suspected to be the reclaimed shaft site. Photos of this regraded area include the field book. If this is the shaft site, there was no sign of settling. Revegetation success at this area was very minimal. Visible at this site was a small wire cable coming out of the ground.

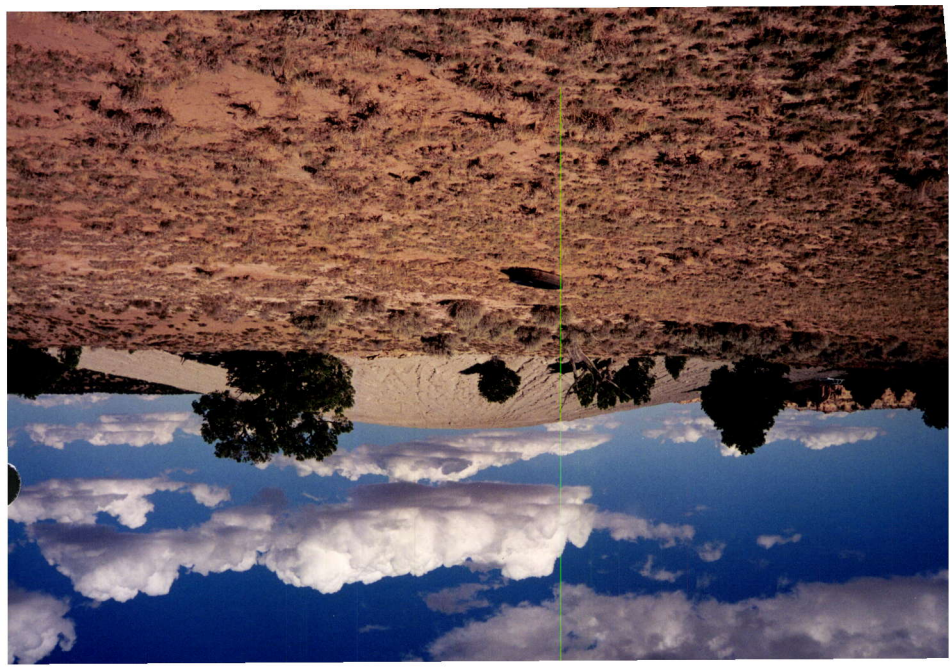
From here I traveled back to the western side of the waste dumps at the mine portal site. Photographs of the large waste pile were taken looking to the north. This photograph includes a

tire on the ground and the state vehicle to the left of the pile. Detail photos show the erosional channels developing on the southwest slope of the large pile. Photographs of the smaller wastepile were taken looking northeast from the top of the large pile. Detail photos of the erosional channels on the southeast side of the large dump were also taken.

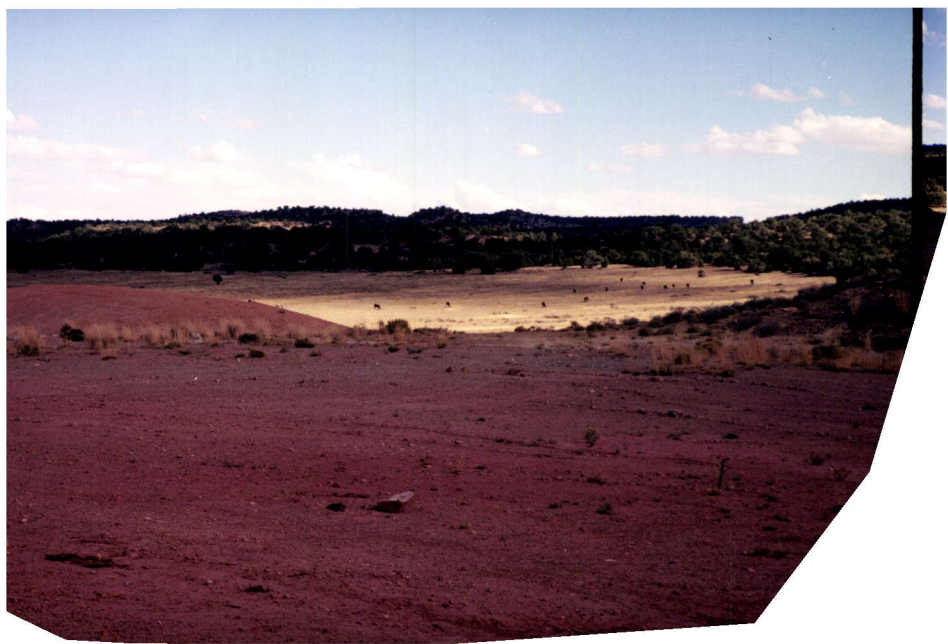
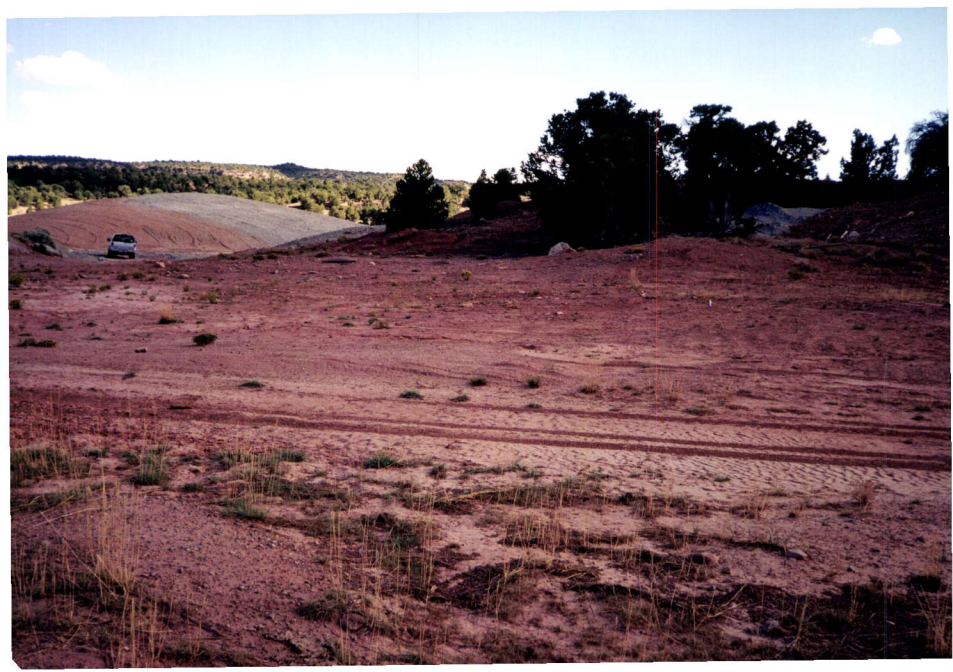
There was some vegetation on the northeast slope of the large pile where topsoil had been placed over the wasterock. Vegetation on this slope showed signs of heavy grazing and there were cattle nearby at this time. The smaller waste dump had some topsoil placed over the waste rock, but the revegetation success was very minimal. The surface of the small dump was smooth and there were some erosional channels on the slopes of this dump as well.
